TECHNICAL REPORT REMR-CS-30

IN SITU REPAIR OF DETERIORATED CONCRETE
IN HYDRAULIC STRUCTURES: EPOXY INJECTION
REPAIR OF A BRIDGE PIER

R. P. Webster, L. E. Kukacka, D. Elling

Final Report

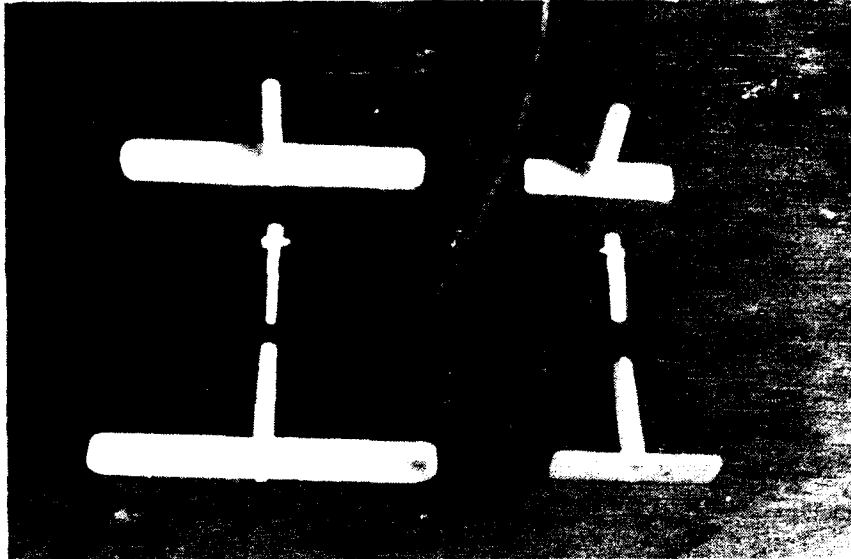
Figure 1. Molded injection ports designed for surface mounted applications
(Type A, left, and Type B, right)

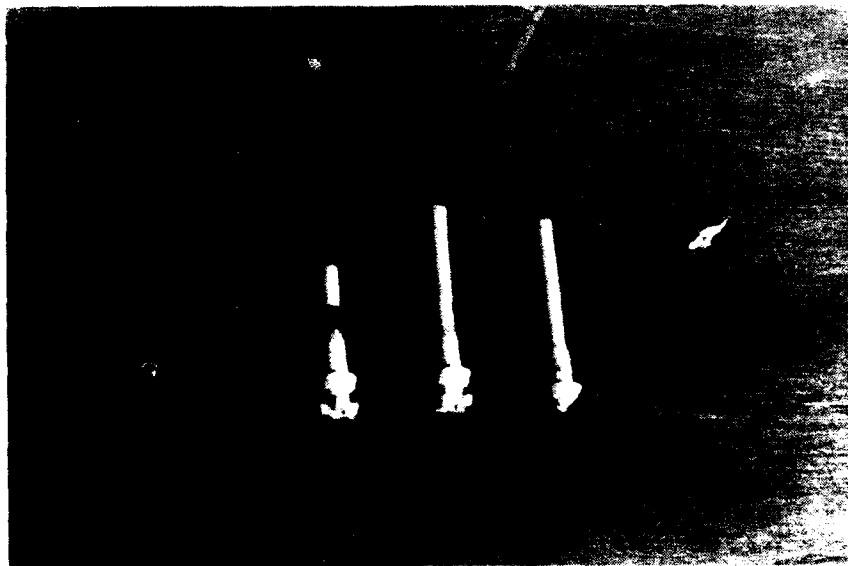
Figure 2. Lily Corporation's Injecti-Port nozzle

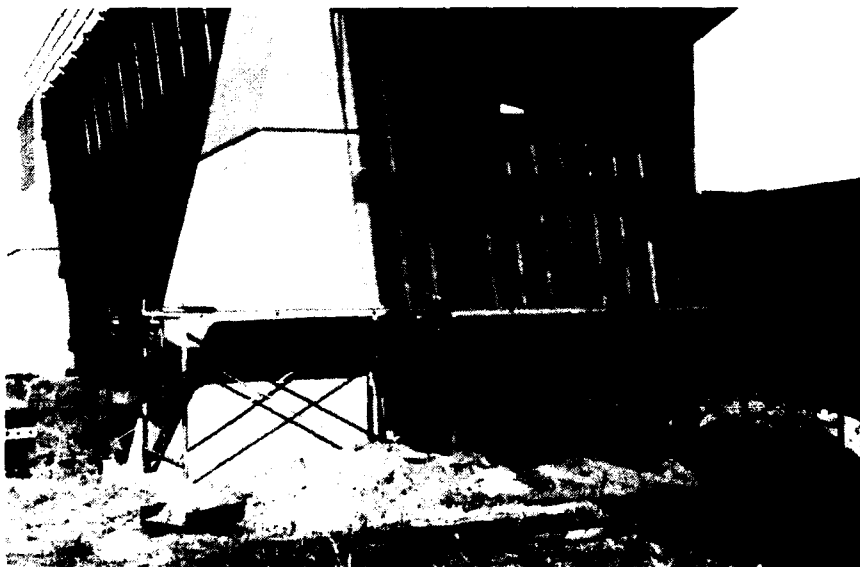
Figure 12. Construction scaffolding in place around pier

53. Five-foot high sections of construction scaffolding were erected along the Iowa and Illinois faces of the pier to provide access to the upper half of the base of the pier (Figure 12). Access to the upstream and downstream faces was provided by planks laid between the scaffolding framework.

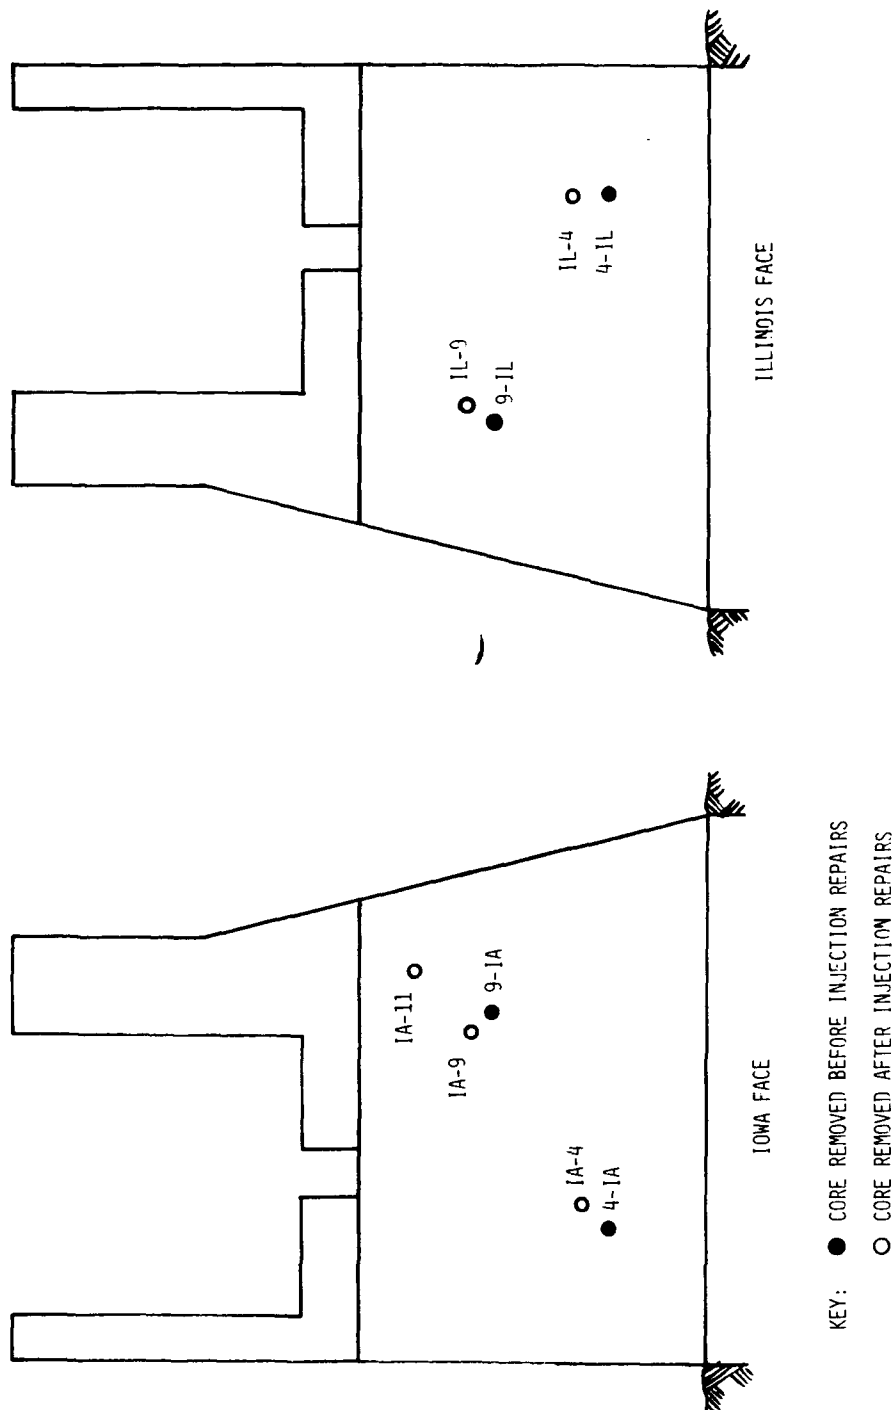
83. Next, personnel from the Rock Island District office removed five 4-in.-diam cores from the Illinois and Iowa faces. Four of the cores were removed from areas close to where the pre-injection cores had been taken (Figure 29). A visual examination of these cores suggested that the crack network within 6 to 10 in. of the surface appears to be filled with epoxy and epoxy was visible as deep as 15 in. from the surface (Figure 30 and 31). Drilling logs are presented in Appendix C.

Figure 29. Location of cores taken before and after epoxy injection repair
